Plots shown in the last meeting

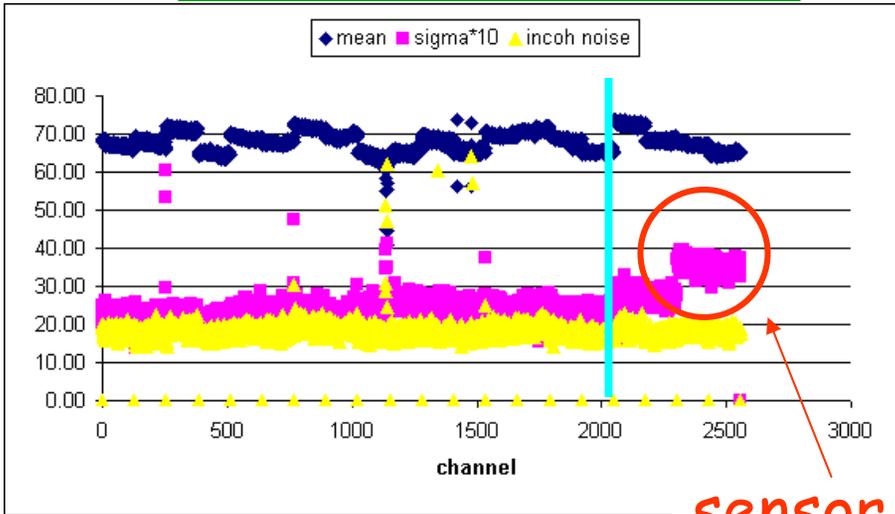
common GND at AC

sensor not glued

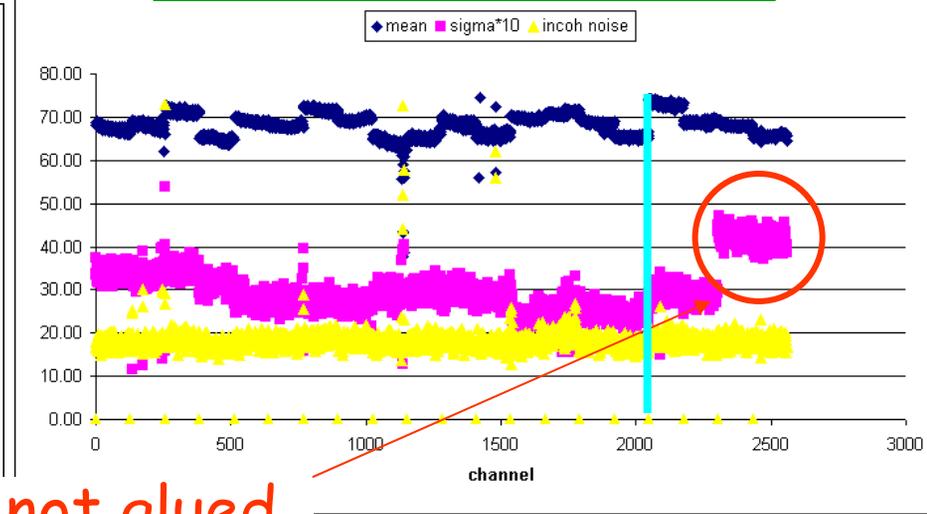
isolated GND at AC

sensor glued

- Looks as if glue the sensor helps to reduce the noise for 10th module with the (semi-)isolated GND scheme, BUT...

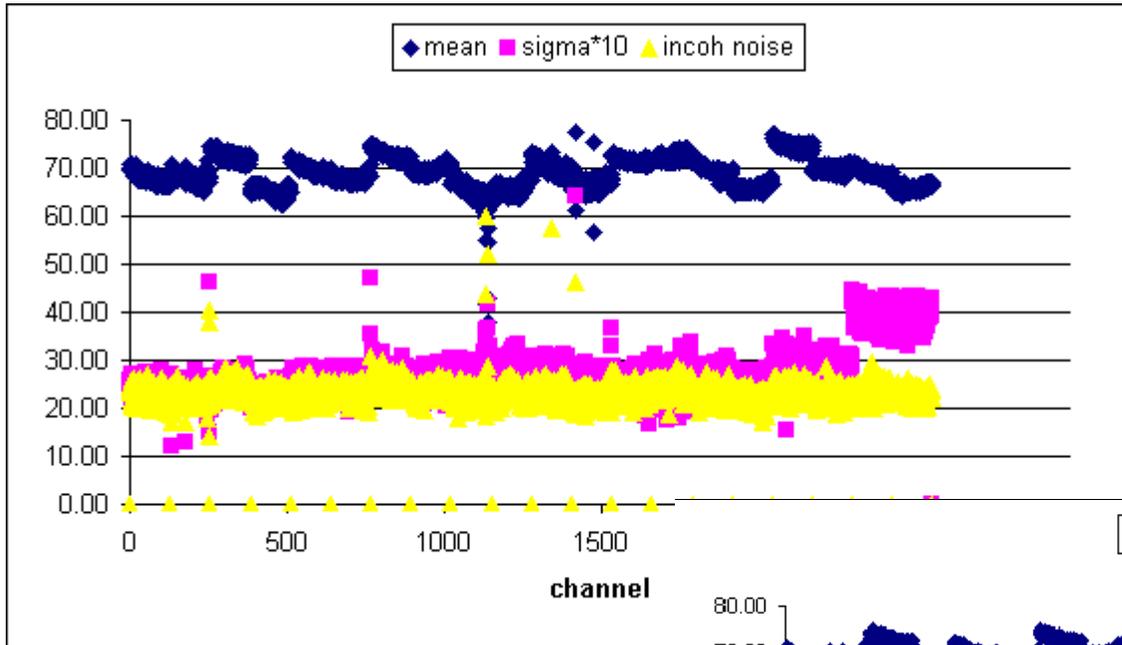
← before
after glueing sensor
↘

- No change with common GND at AC

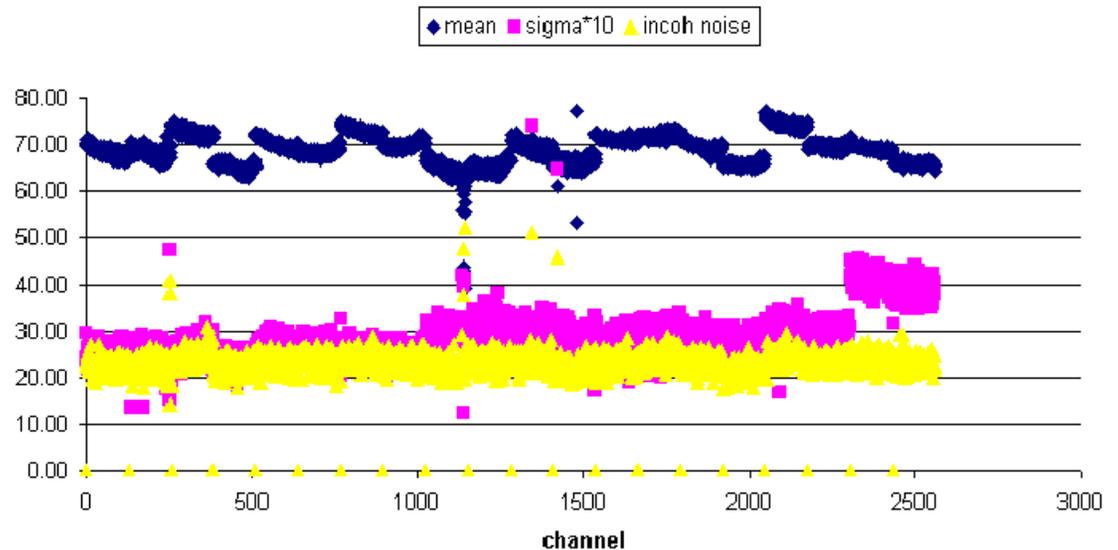
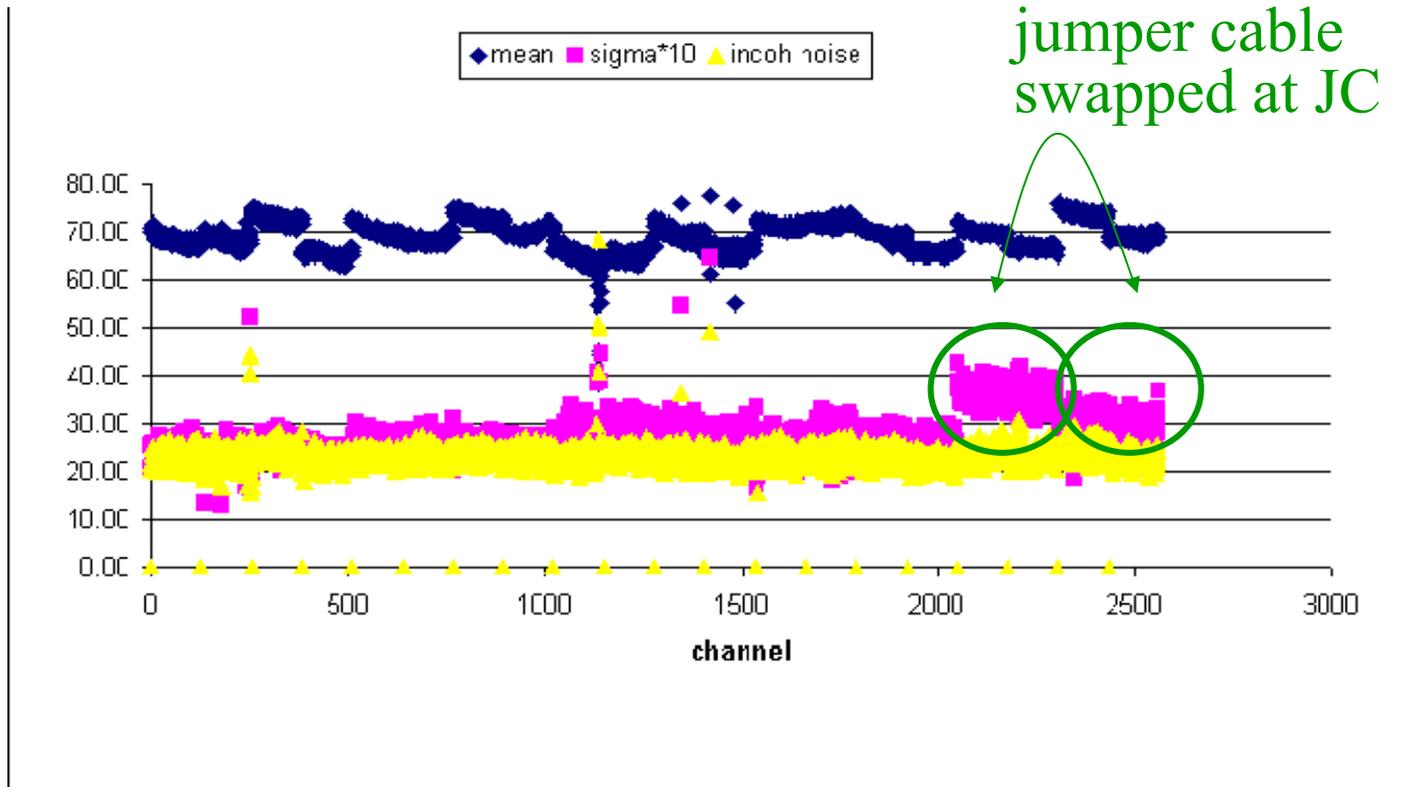
Bad module ?

- The module really has higher noise

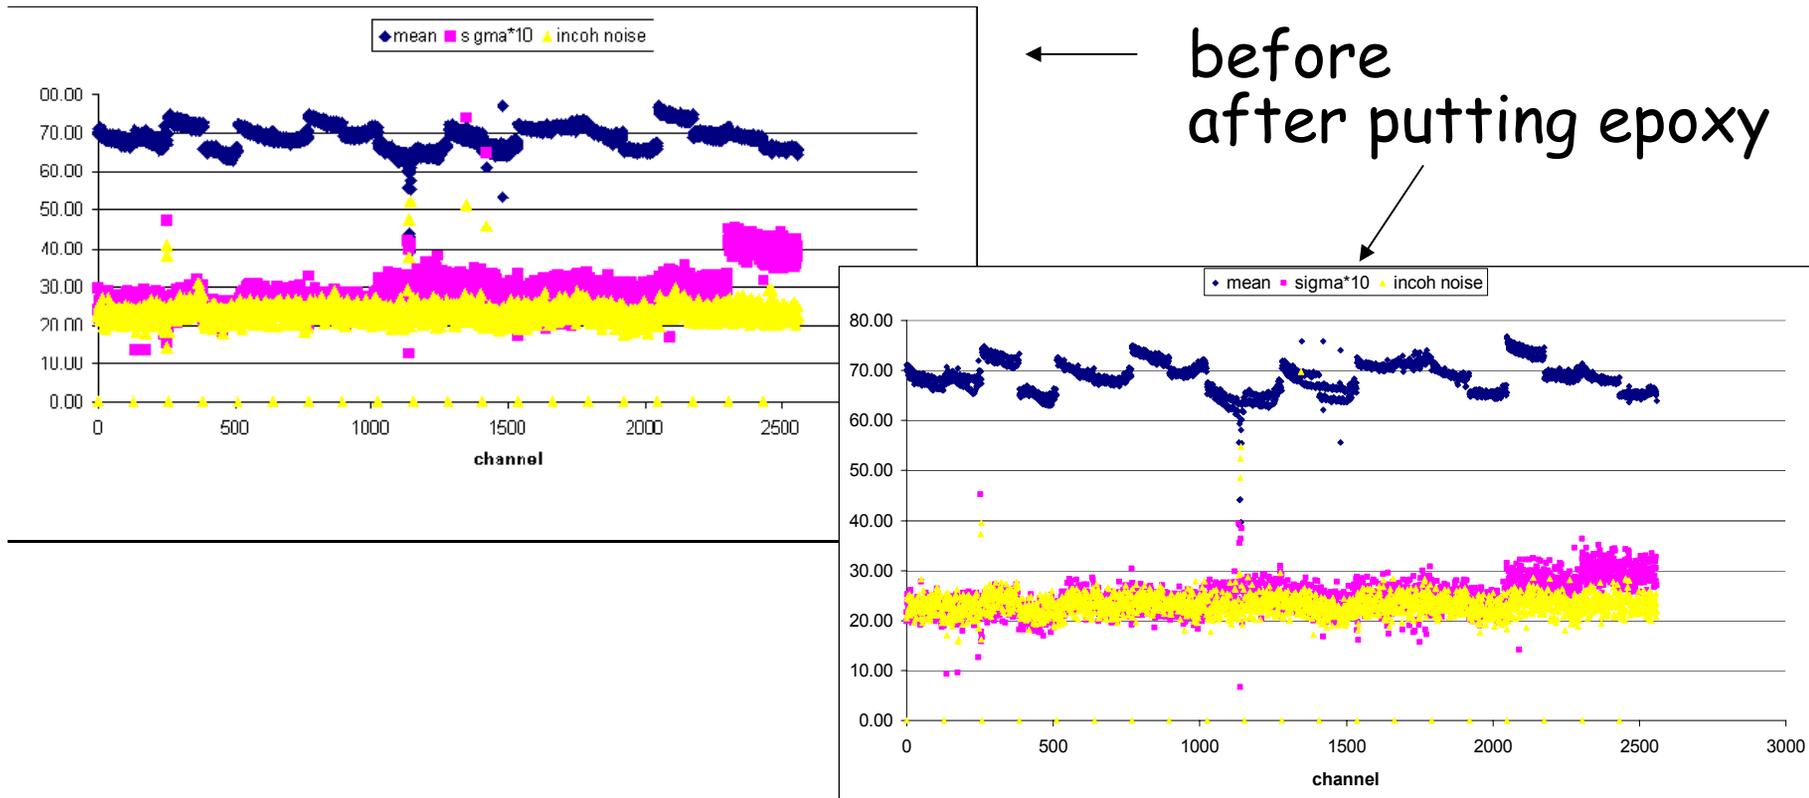
Fix

- The sensor ground is properly connected to the support structure, but HV capacitor for the filter \rightarrow put conductive epoxy

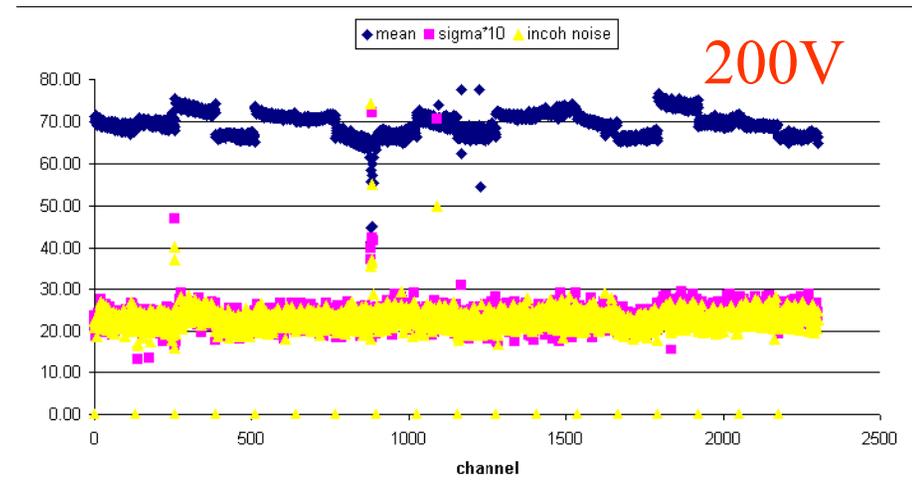
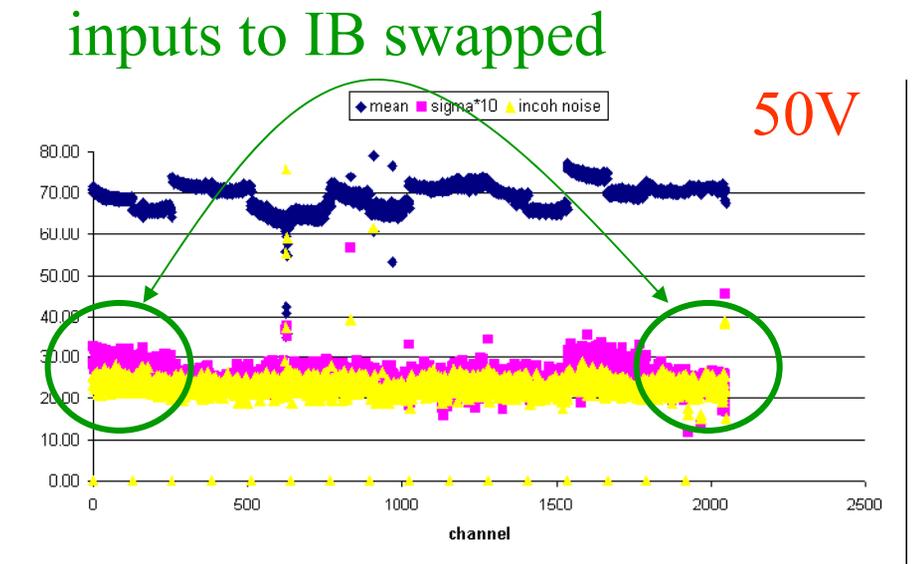
- The last two modules (using different IB) has slightly higher noise
 - Increasing bias voltage from 50 to 200 V reduces the noise (Andrei)
 - Swapping the inputs to IB indicates no problems in IB
- just under depletion(?)
